SUBJECT: Division of Water Water Quality Certifications
Somerset Northern Bypass, Item No. 8-59.50
Pulaski County, Kentucky

12. PROJECT NAME OR TITLE <i>(see instructions)</i> Construction of a section of Somerset Northern Bypass, Item No. 8-59.50			
13. NAME OF WATERBODY, IF KNOWN <i>(if applicable)</i> Pitman Creek, Dry Branch, and Smiths Branch		14. PROJECT STREET ADDRESS <i>(if applicable)</i> N/A

SUMMARY OF IMPACTS
Item No. 8-59.50
(Stations are mainline unless otherwise noted)

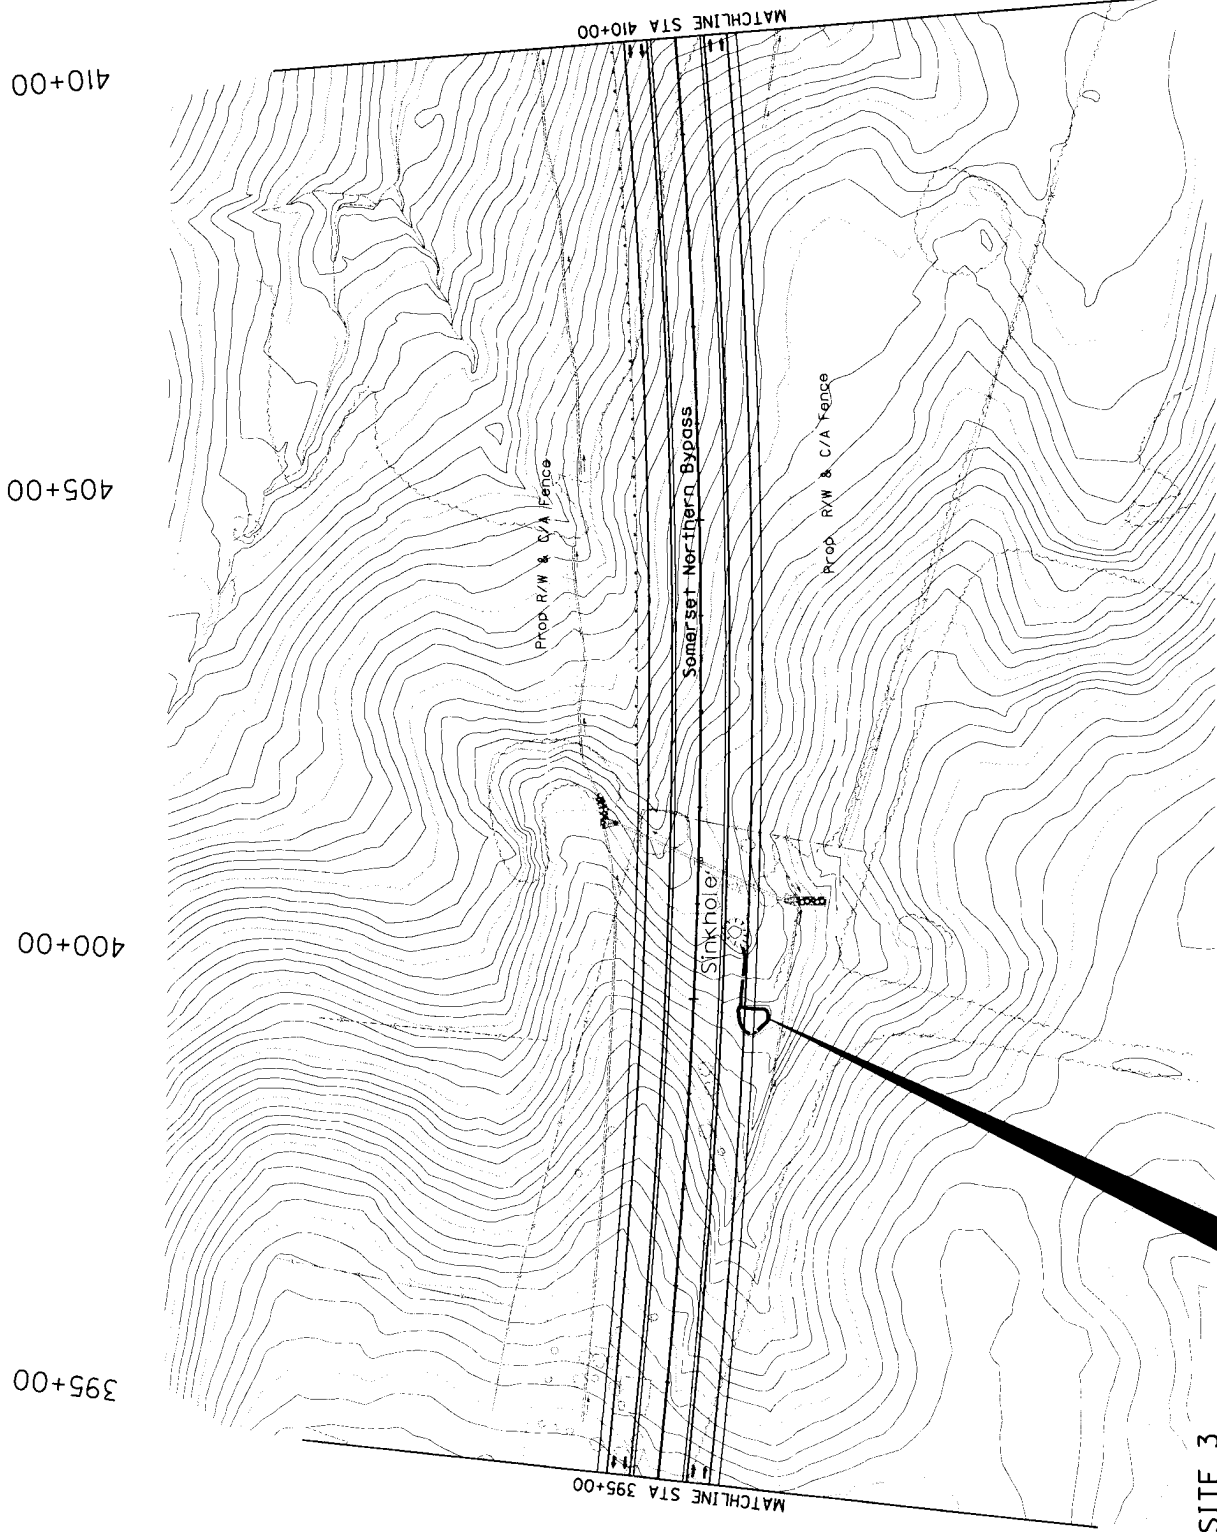
SITE 3

Pond #2	Impact= 0.015 ac.
EPH #2	Impact= 64'

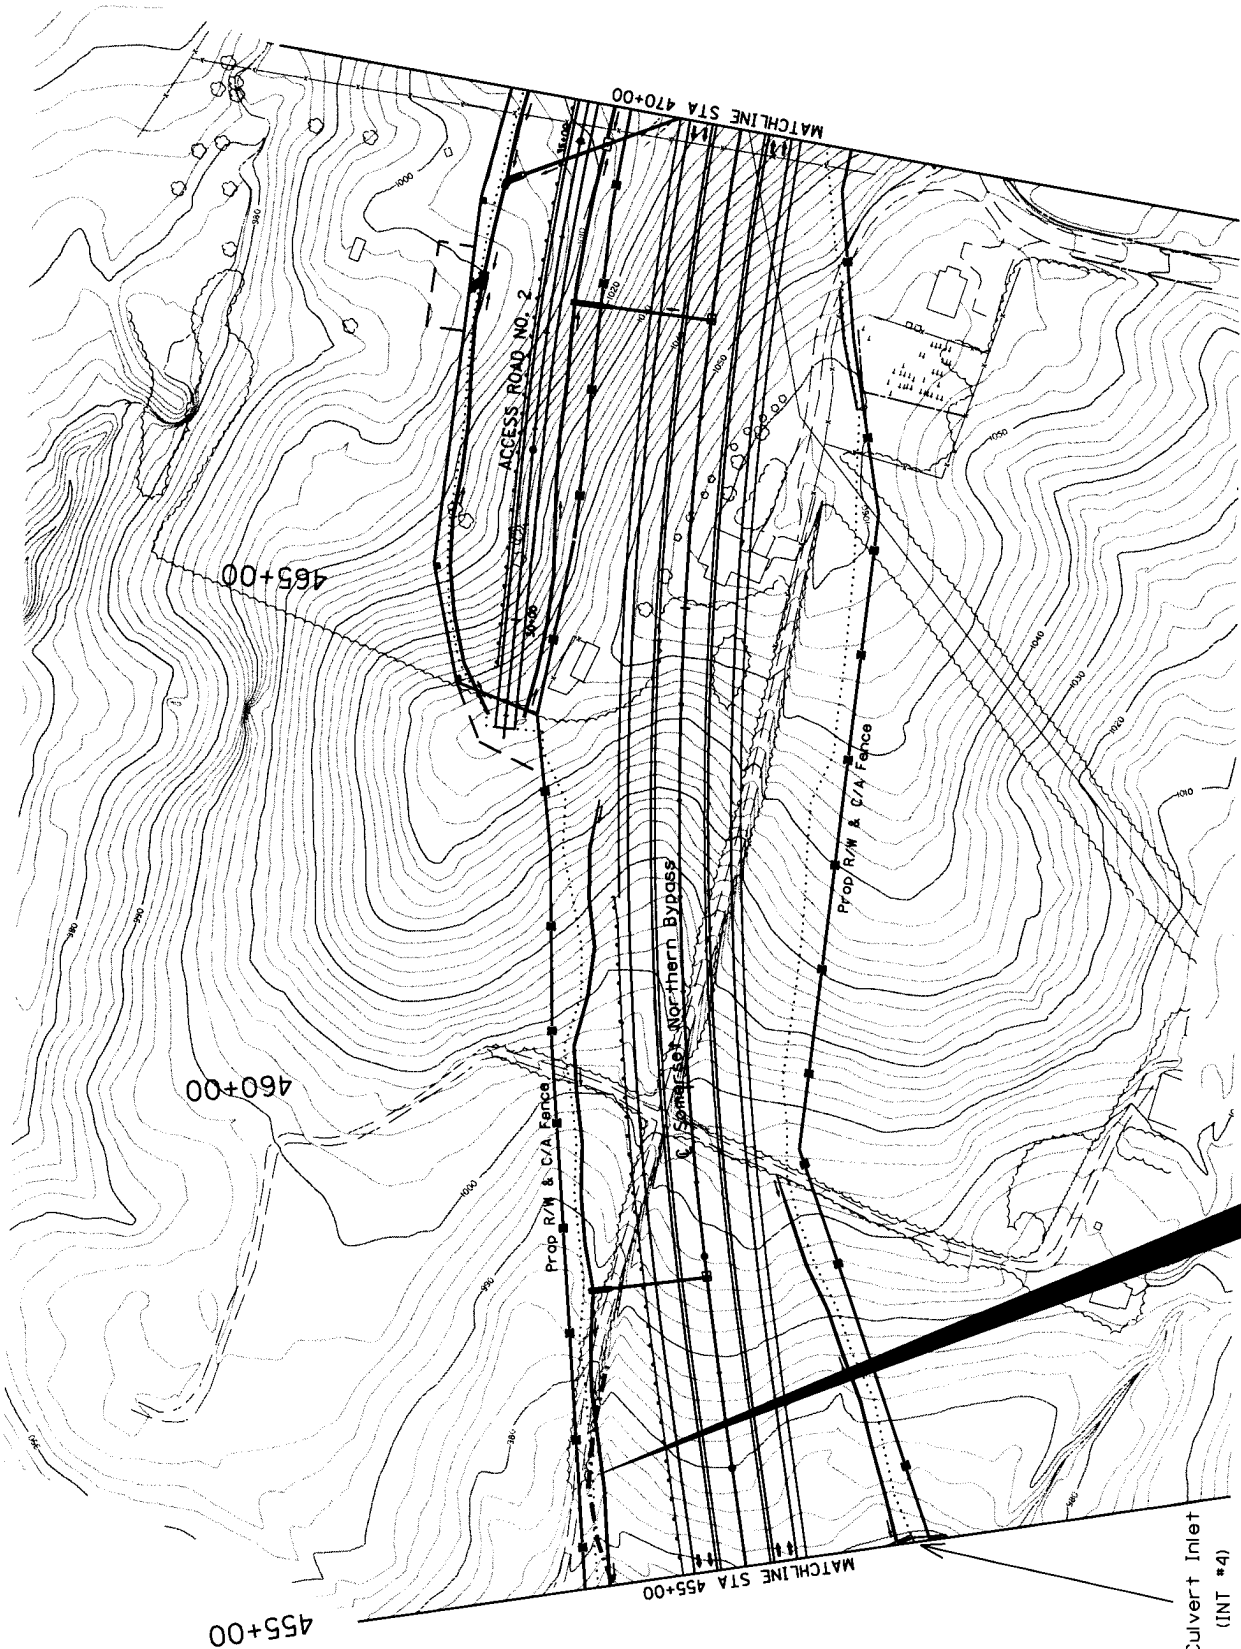
Kentucky Transportation		PROJECT: Somerset Northern Bypass		STREAM: UT to Pitman Creek	
COUNTY: PULASKI	STATE: KENTUCKY	STA 455+00 to STA 470+00	ITEM: 8-59.50	Plan Sheet No. 11

SITE 9
 EPH #4
 Cont. from Plan Sheet 10

9. Sta. 454+52 – Construct 306' of pipe culvert, with 13' of inlet and 32' of outlet channel improvement; on a tributary to Pitman Creek. The replaces **393' of intermittent stream** (INT#4). Additionally, relocate **312' of ephemeral** channel (EPH#4) into 330' of roadside drainage channel. The total impact to waters is **0.059 acres (0.045 ac. of intermittent and 0.014 ac. of ephemeral)**. The drainage area affected is **46.4 acres**. The site is located near N37-09-06, W84-35-25. (Nationwide Permit No. 14, Individual WQC)

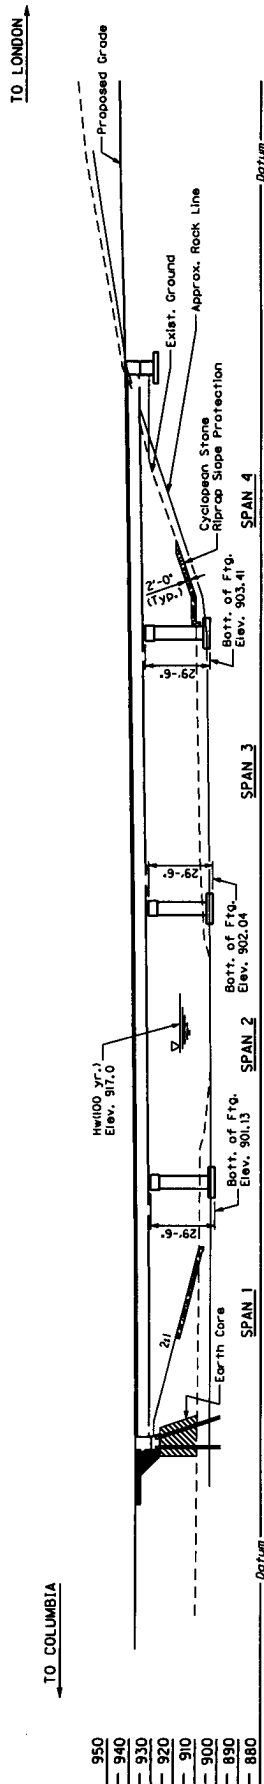
SECTION ALONG C EASTBOUND STRUCTURE

4 Spans at 120'-0", 125'-0", 125'-0", 120'-0"
 44'-0" Bridge Roadway
 60° Skew Rt. ~ 140'-0" Shoulder Width at Bridge ~ 2:1 Fill Slopes

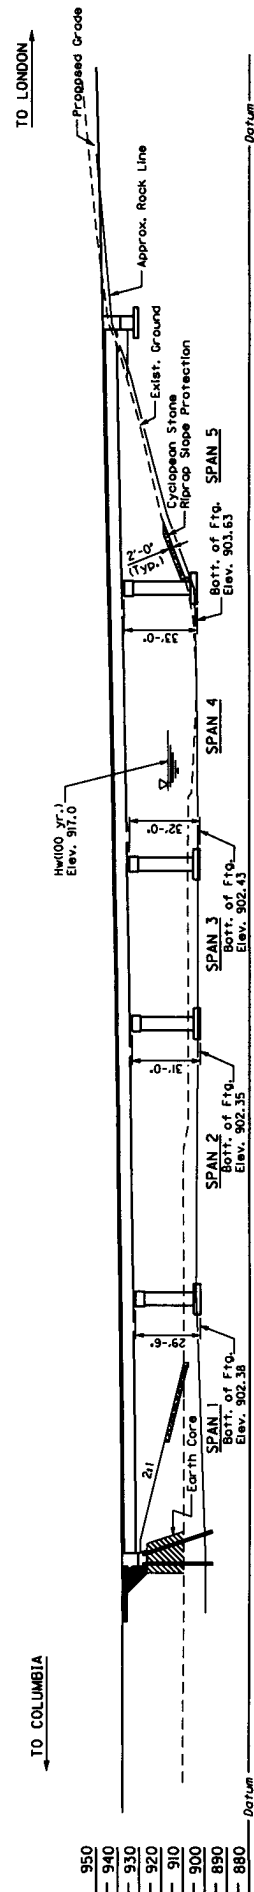
SECTION ALONG C WESTBOUND STRUCTURE

5 Spans at 120'-0", 125'-0", 73'-0", 125'-0", 120'-0"
 44'-0" Bridge Roadway
 60° Skew Rt. ~ 140'-0" Shoulder Width at Bridge ~ 2:1 Fill Slopes

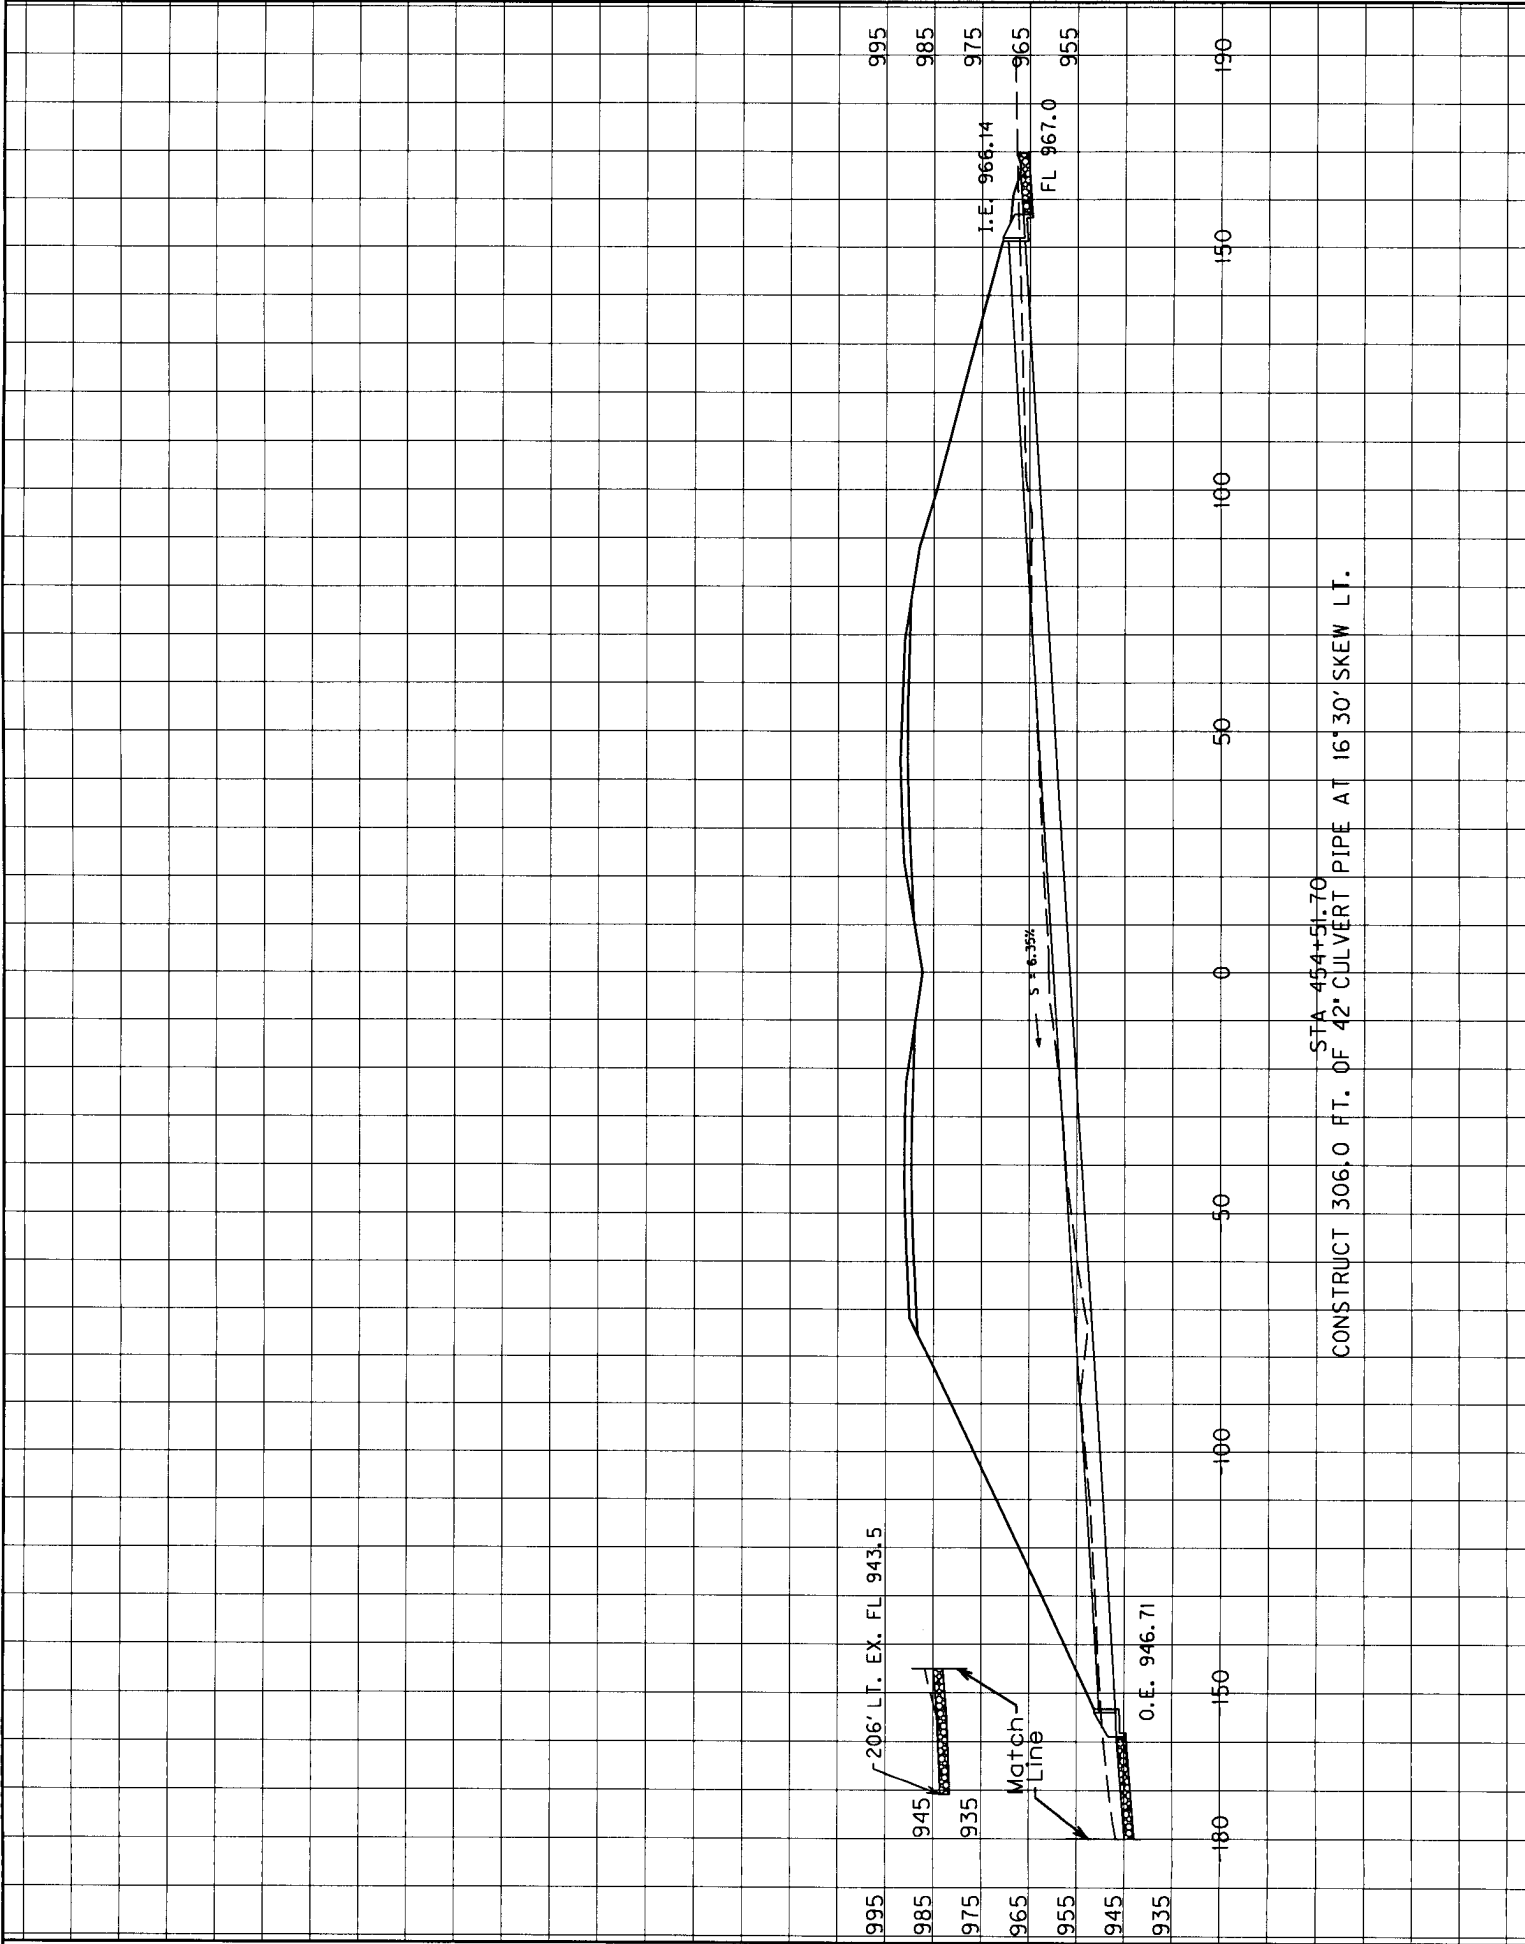
STA 454+51.70
CONSTRUCT 306.0 FT. OF 42" CULVERT PIPE AT 16°30' SKEW LT.

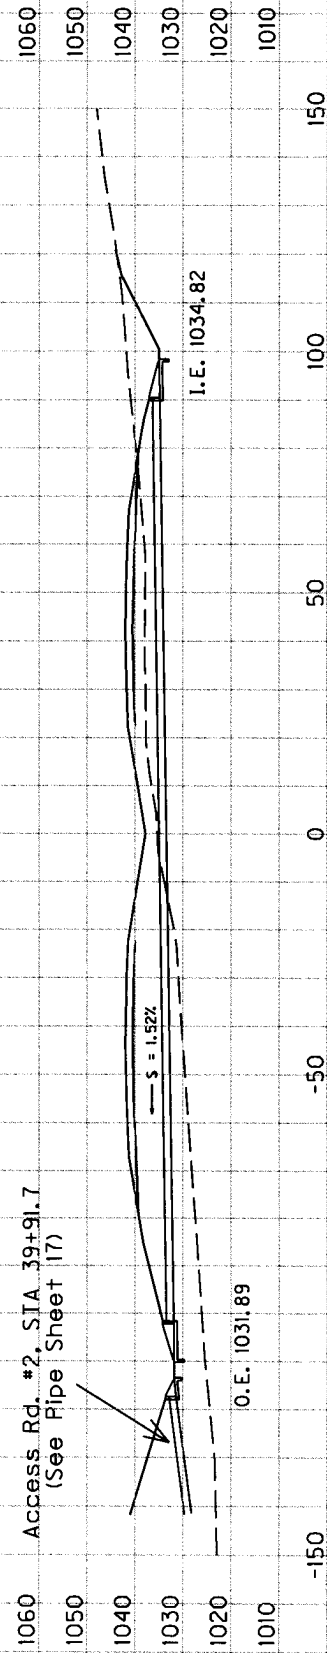
STA 474+83.90
CONSTRUCT 192.6 FT. OF 18" CULVERT PIPE

10. Sta. 474+84 – Construct 192.6' of pipe culvert (Sta. 474+83.9) with 14' of outlet/inlet to another 122.2' culvert (Access Rd #2, Sta. 39+91.7) with 36' of outlet channel; on a tributary to Pitman Creek. This replaces **236' of ephemeral** channel (EPH#5). The impact to waters is **0.005 acres**. The drainage area affected is **8.5 acres**. The site is located near N37-09-16, W84-35-03. (Nationwide Permit No. 14)

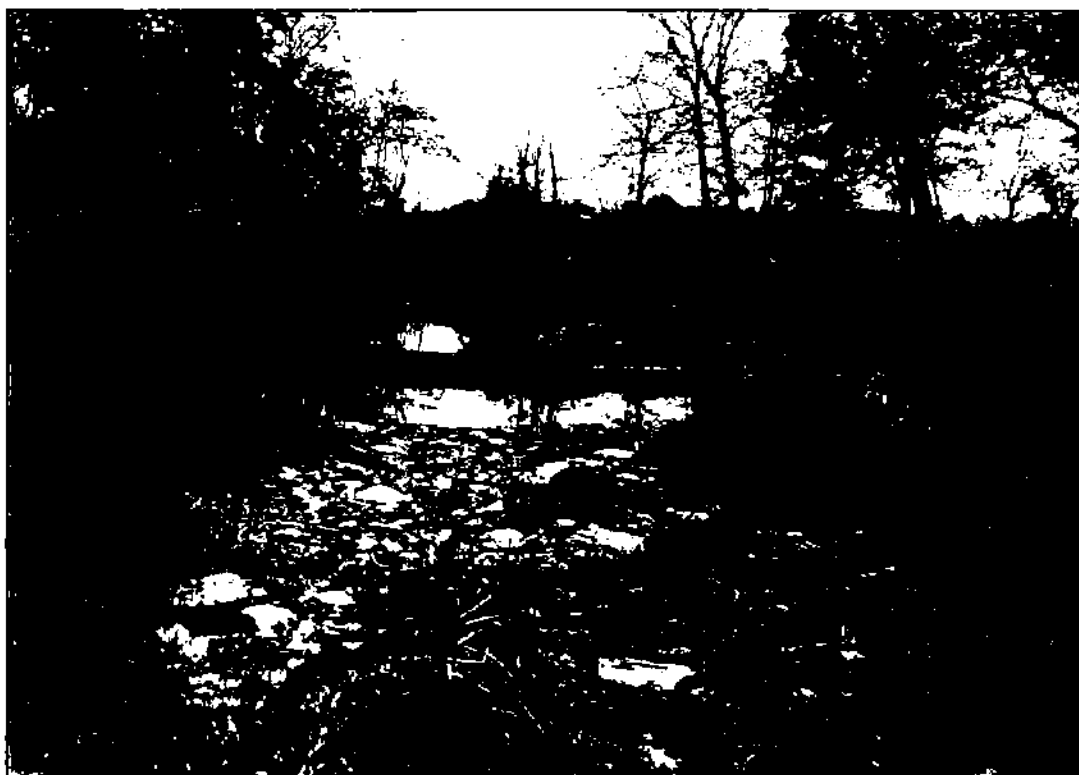
PER #2 (Pitman Creek) – Looking downstream near proposed bridge site.
